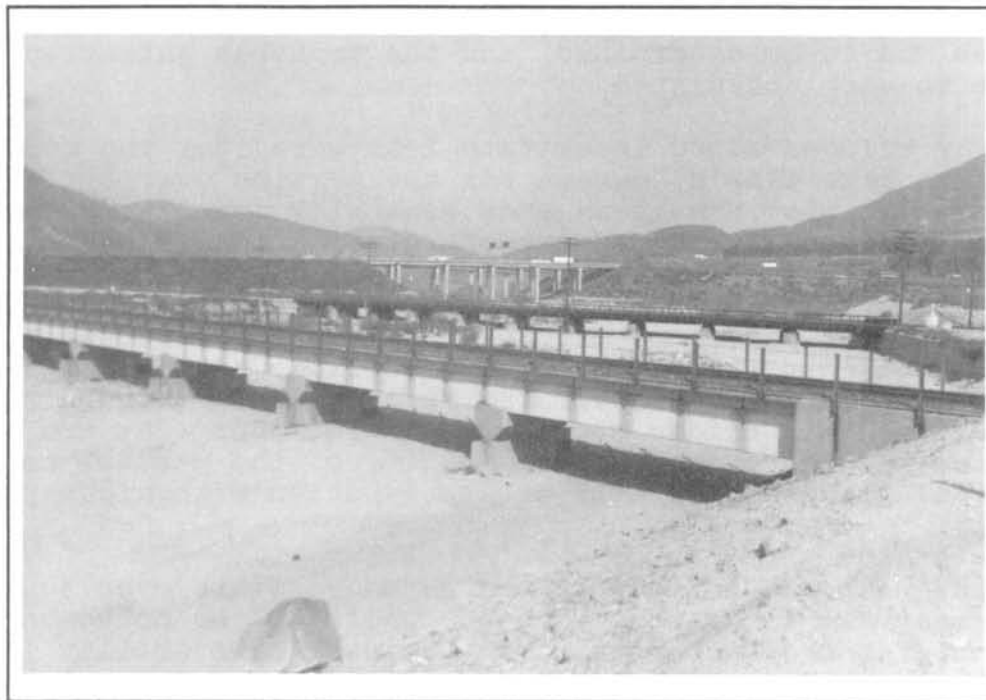
Figure 28 Railroad Bridges In Cajon Wash (I-15 Bridge
In The Background)

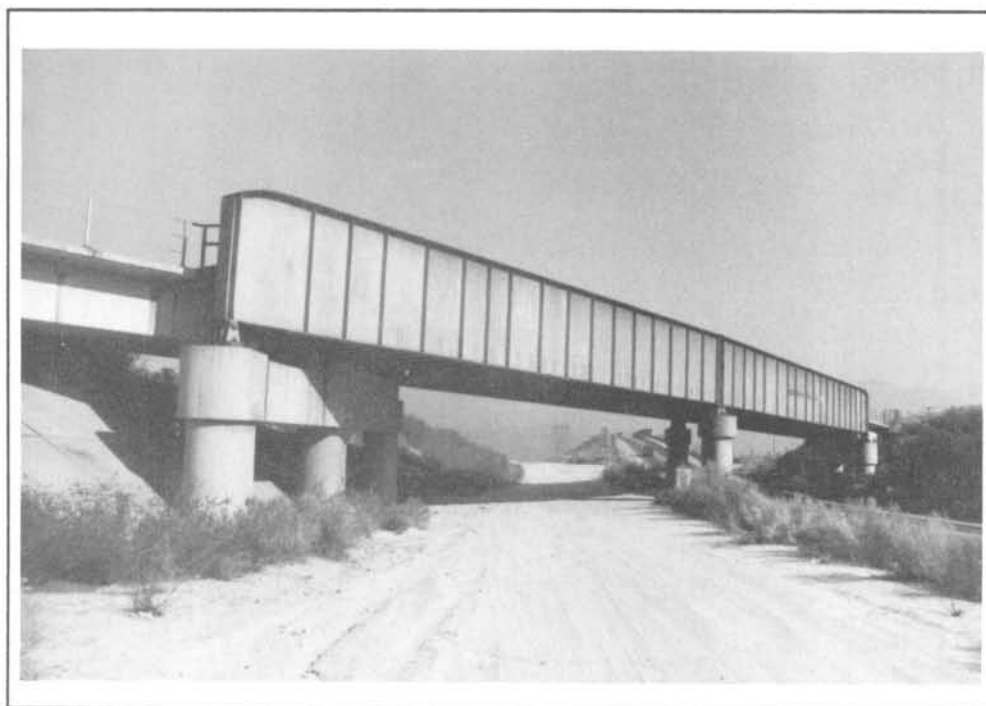
Figure 29 Railroad Bridge Over Highway 138
(Collapse Expected)

to MMI= VIII shaking intensity zones or are on potentially liquefiable soils. The failure of the Bridge shown in Figure 29 was responsible for much of the access time estimate for repair of I-15, since it blocked Highway 138 from being an immediate detour route for equipment needed for the I-15 repairs.

- (5) The area just north of the section of Highway 138 and west of Highway I-15. Problems with pipelines and power lines have already been noted at intersection points 47, 48, 49, 51, 52, and 53. There is also a possibility of partial collapse of the Southern Pacific railroad bridge over Highway 138 (Figure

29). An additional delay time of 30 days was added for access involving this bridge, over and above the 30 days to clear fire hazards related to pipeline damage.

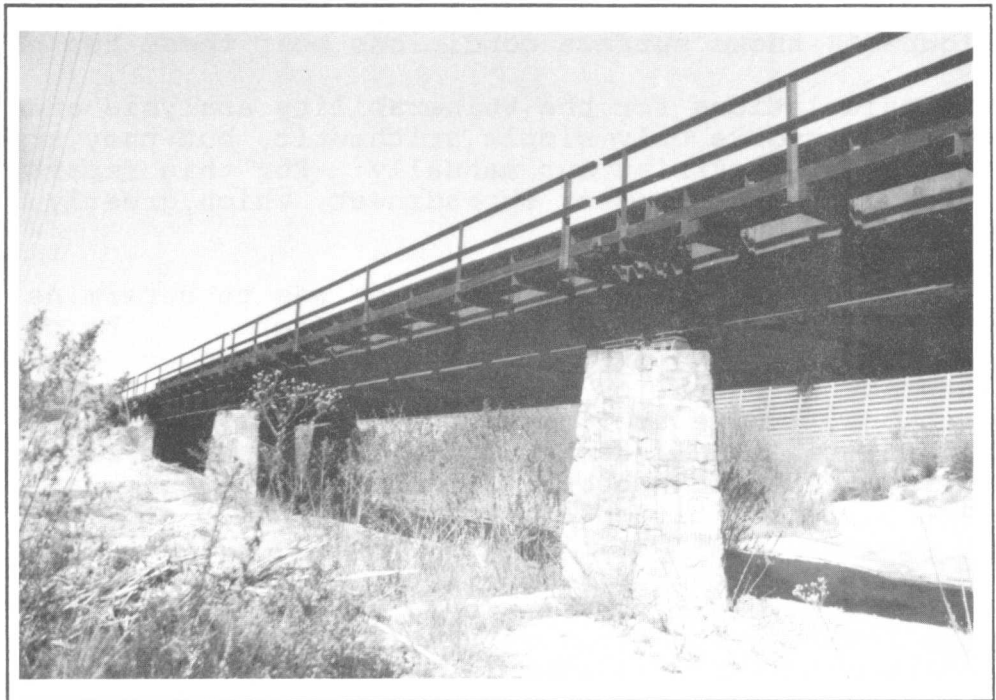
Figure 30 Santa Fe Railroad Rubble Masonry Pier Bridge

There is one bridge on the Santa Fe railroad just south of the I-15 truck weighing station which is founded on rubble masonry piers on sandy soil with a high water table (Figure 30). Loss of one or more spans is anticipated. That is contrasted to the Union Pacific railroad bridge at the

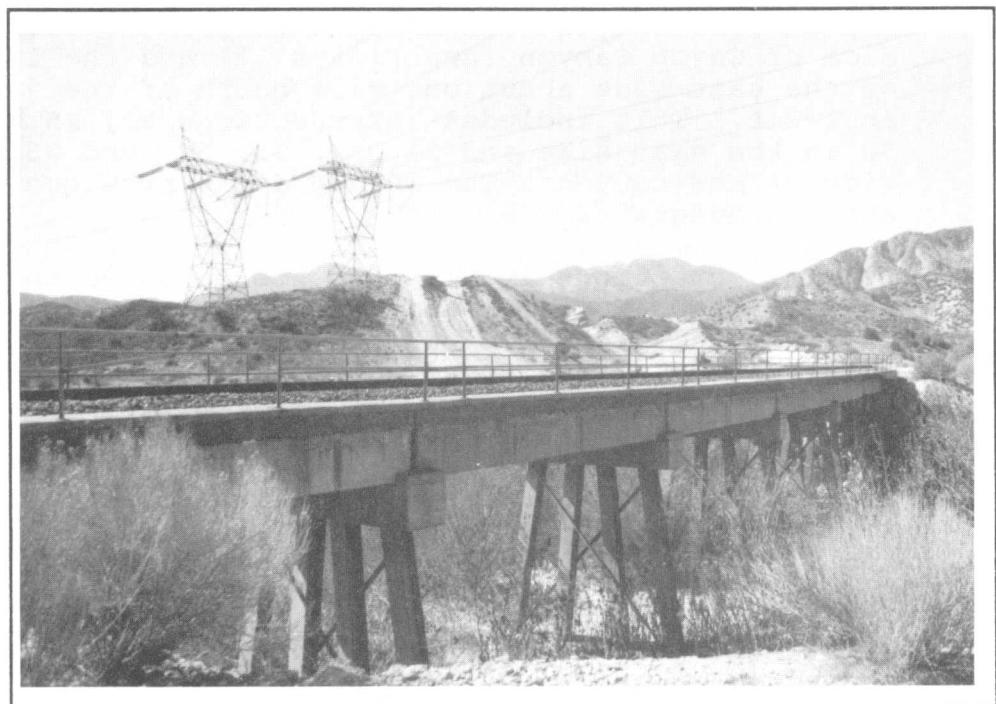
Figure 31 Union Pacific Railroad Bridge With Power Lines Overhead

same location (Figure 31) which has steel column, pile piers. Figure 14 shows surface conditions near these two bridges.

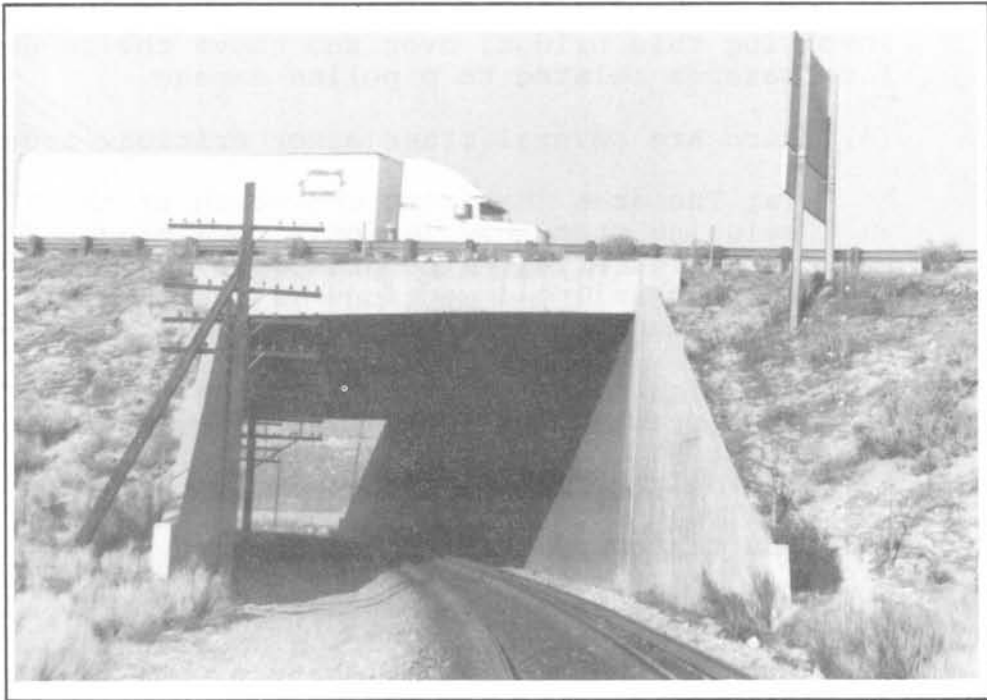
(b) Highway Structures 0796, 0797 and 0827 which carry I-15 over the rail lines at Alray and Gish at intersections 55 and 57 (Figure 32). These structures may only be lightly damaged, but a 10 day delay in railroad access is assumed to permit time for inspection and temporary shoring if required.

Figure 32 Typical I-15 Box Bridge Over the Railroads

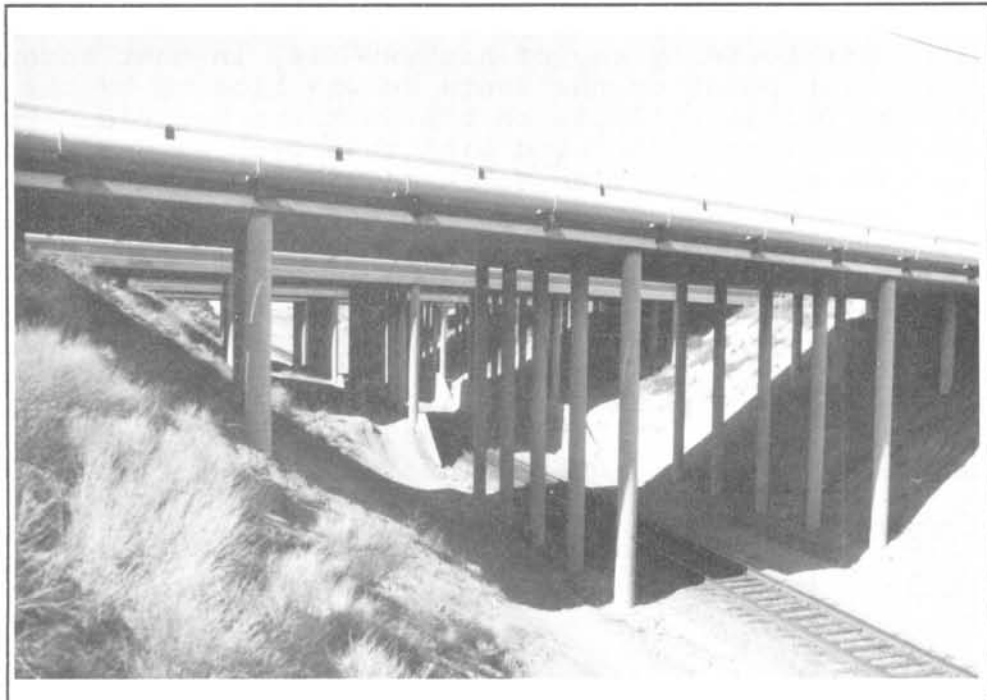
(c) The I-15 bridge 0664 (Figure 33) over the Southern Pacific tracks north of the pass at intersection 83 is expected to be lightly damaged, but 10 days delay is allowed for inspection (also see Figure 15 which shows details of this bridge).

Figure 33 I-15 & Access Road Bridges Over the Southern Pacific Railroad
